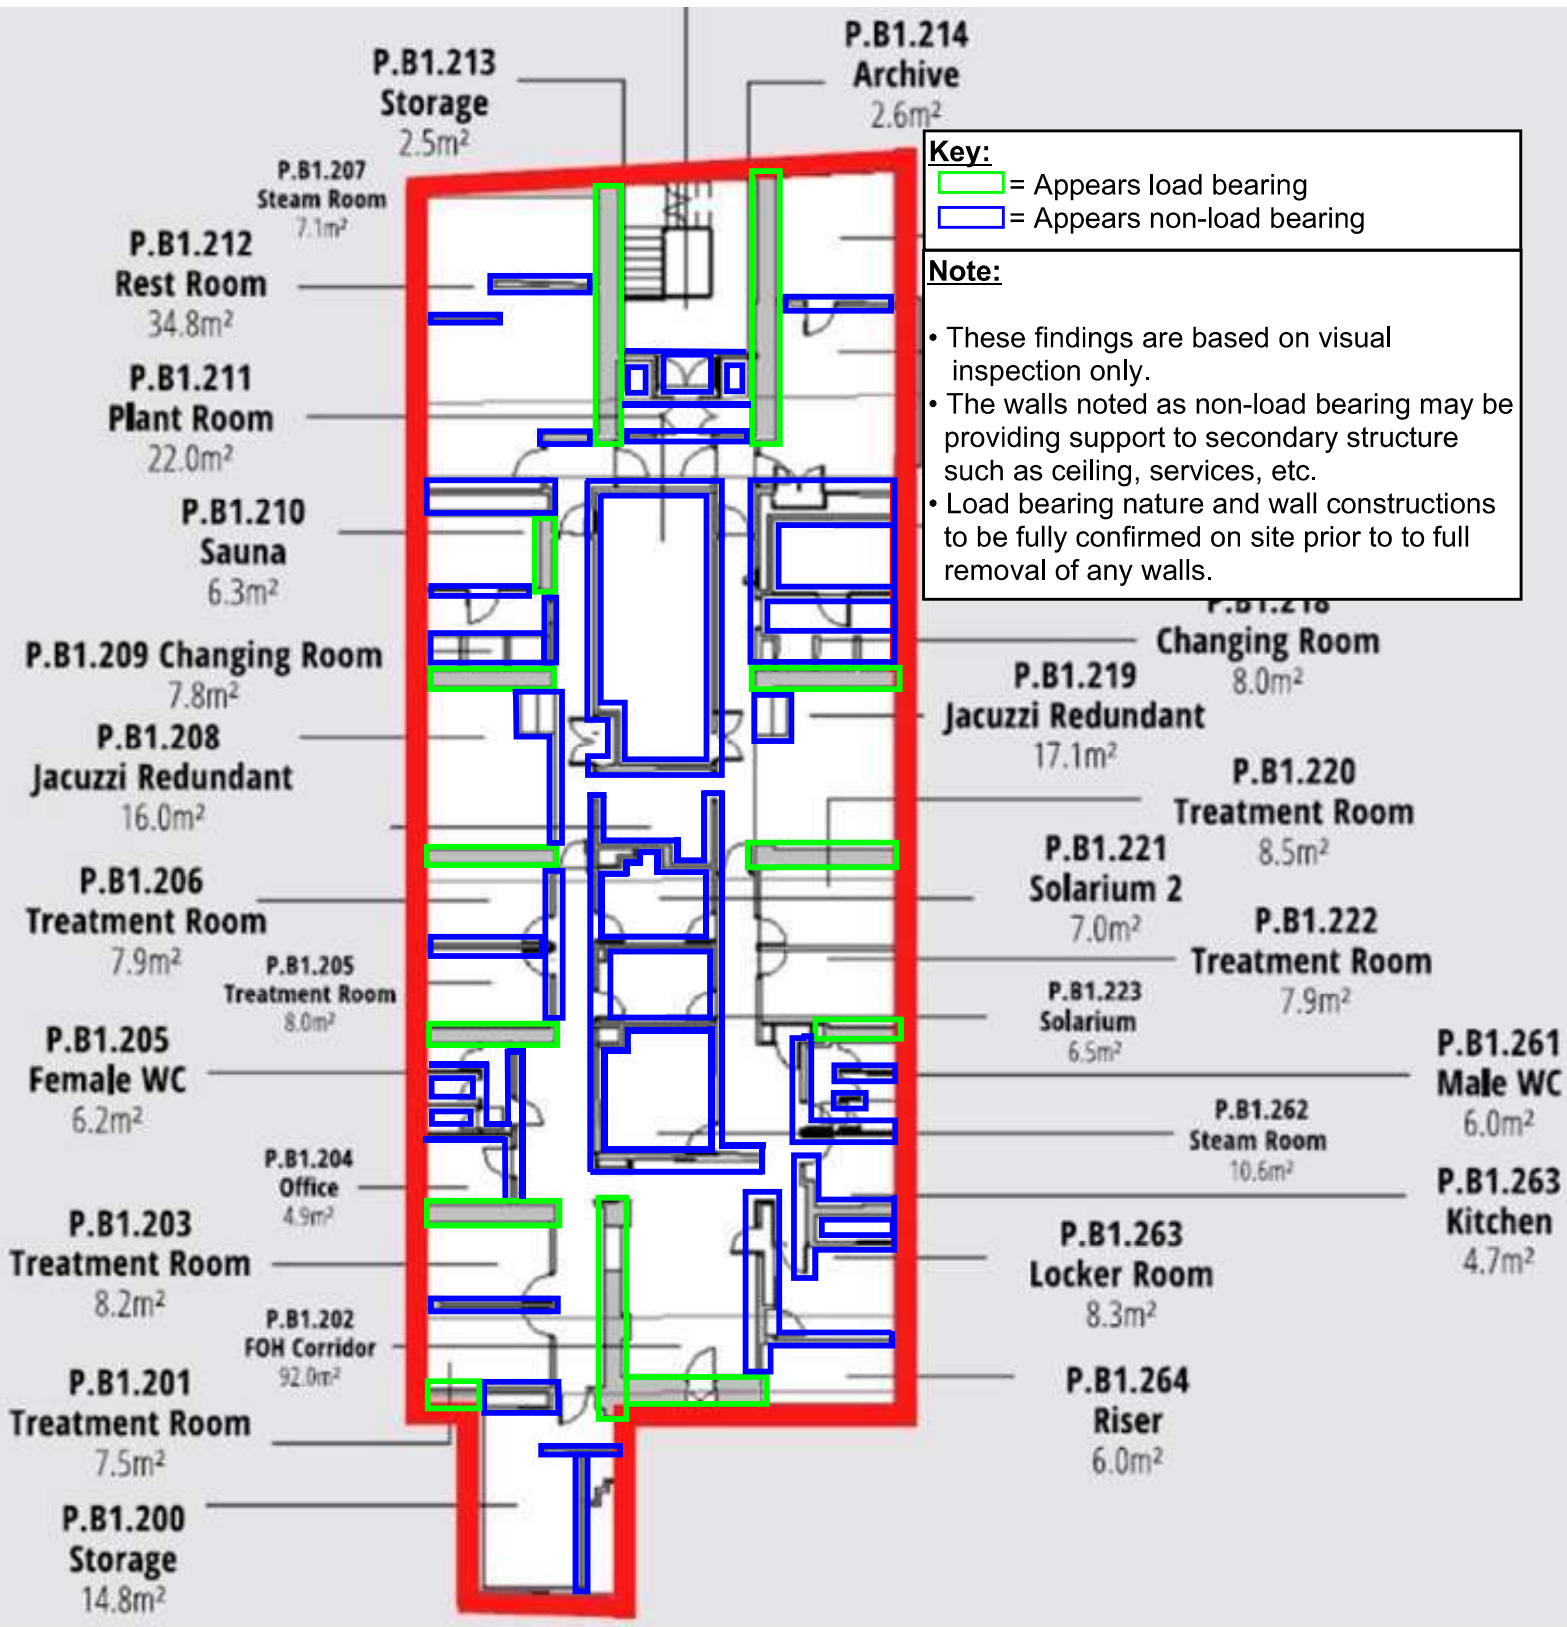
Key:
 = Appears load bearing
 = Appears non-load bearing

- These findings are based on visual inspection only.
- The walls noted as non-load bearing may be providing support to secondary structure such as ceiling, services, etc.
- Load bearing nature and wall constructions to be fully confirmed on site prior to full removal of any walls.
